NATIONAL TRANSPORTATION SAFETY BOARD  
OFFICE OF MARINE SAFETY  
WASHINGTON, D.C. 20594

# ERRATA

## Group Chairman's Factual Report SURVIVAL FACTORS

*El Faro*  
DCA16MM001

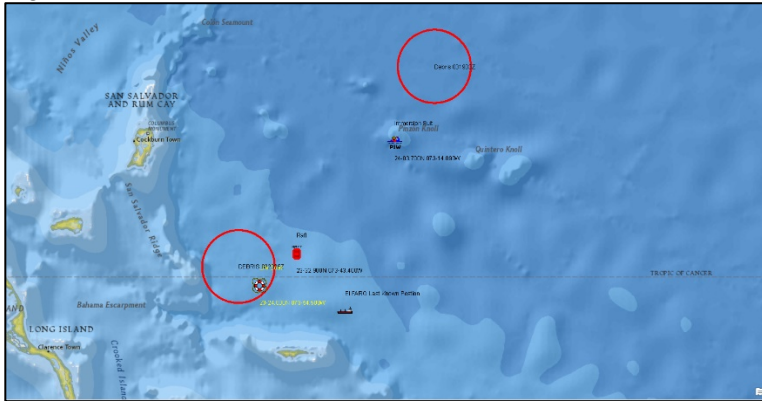
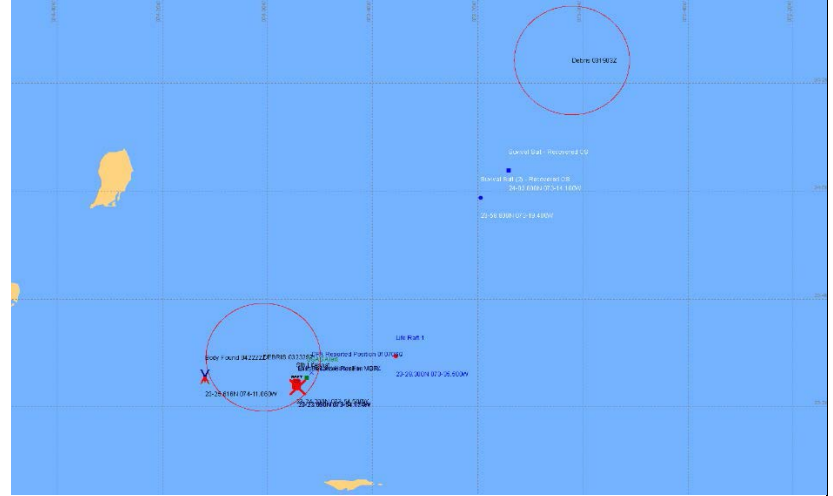
| Page/<br>Line | Original | Correction |
|---|---|--|
| 27 | Figure 11<br> | Replace Figure 11<br> <p>Replace with Figure 11. The red “X” is the <i>El Faro</i>’s last position recorded on the VDR. The red circles are the two debris fields. The</p> |

| Page/<br>Line | Original | Correction |
|---|--|--|
| | <p>Figure 11. Last known position of <i>El Faro</i> (ship symbol) and two debris fields (red circles). First debris field was located bearing 293° true at 31 nm from the last known position; second debris field was located bearing 020° true at 72 nm from <i>El Faro</i>'s last known position. Each debris field had a radius of about 10 nm; the distance between the debris fields was 76 nm. Major survival gear found were lifeboat (lifering symbol), liferaft (red raft symbol), and immersion suit with human remains (PIW symbol). (Coast Guard graphic)</p> | <p>debris field to the southwest is the main debris where the vessel sank. The second debris field to the northeast (044° true at 77 nm) is the “down range” debris field. Each debris field had a radius of about 10 nm. Major survival gear found were the starboard lifeboat, liferaft (red dot), an immersion suit with human remains (blue and red “X”), and two immersion suits between the two debris fields. (Coast Guard graphic)</p> |

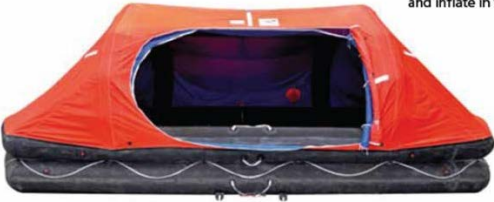
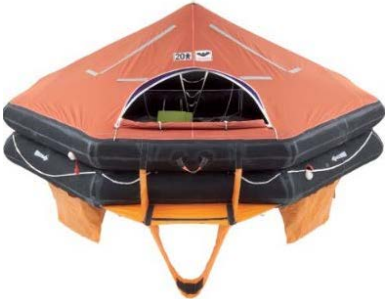
| Page/<br>Line | Original | Correction |
|---|---|--|
| 49 | <p>Figure 23</p> | <p>Replace Figure 23 with:</p> |

| Page/<br>Line | Original | Correction |
|---|---|---|
| | <p>Throw-overboard liferafts are stored in containers on deck and inflate in the water when the painter line is pulled.</p> | <p><b>Throw-overboard liferafts, standard</b></p> <p>Throw-overboard liferafts are stored in containers on deck and inflate in the water when the painter line is pulled.</p> <p>Standard SOLAS liferafts are available for:<br/>6, 8, 10, 12, 16, 20, 25 and 35 persons.</p> <p>Self-righting liferafts are available in the following sizes:<br/>25, 51, 101 and 151 persons.</p> |
| 49/2 | Figure 23 text: Figure 23. Viking throw-overboard liferaft, self-righting (Viking life-saving equipment illustration) footnote “48” | Replace text with: Figure 23. Viking throw-overboard liferaft, standard SOLAS type DK (Viking life-saving equipment illustration) footnote “48” |
